Deba bridge rehabilitation

Deba, Spain / 2019

Diputación Foral de Gipuzkoa Diputación Foral de Gipuzkoa Emergency monitoring, rehabilitation project and monitoring

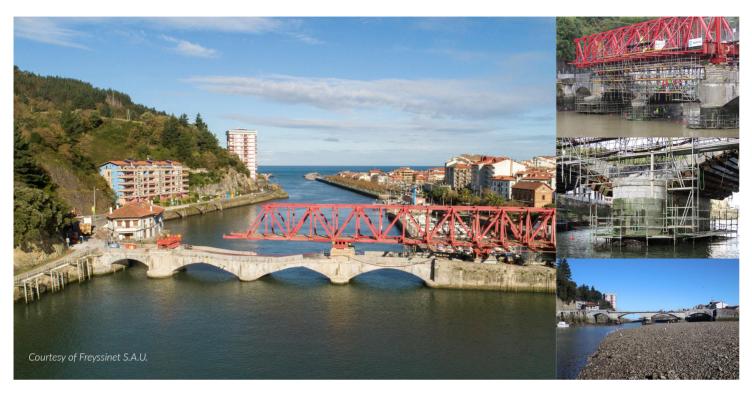
The Deba bridge was inaugurated in 1866 as a bridge with three masonry vaults and a metallic movable span, replaced in 1950 by a concrete vault clad in limestone. The three masonry stone piers are located in the River. Their original foundations were typical for this kind of bridges, made out of wooden piles. The Deba side abutment has a similar foundation, while the Mutriku side abutment rests on rock. The bridge has experienced several interventions throughout its life.

In the early hours of July 5th, 2018, the central pier partially collapsed, dragging the adjacent vaults with it and leaving the bridge in a precarious state near destruction. The reason was the loss of capacity of the existing foundation due to the xylophagous attack, the Teredo navalis mollusk among them.

The first phase (emergency phase) of the intervention consisted of reinforcing piers 1 and 3 using micropiles to place a movable scaffolding system (MSS) launched from the Deba side on top of them. After that, the central vaults were supported on wooden panels hanging from the MSS. The central pier could be partially unloaded with this system, and the bridge was safe from total collapse. In addition, to allow pedestrian access compatible with the works, a provisional walkway was installed inside the MSS.

In the second phase of the intervention, the complete rehabilitation of the bridge has been carried out. According to the project, the bridge was restored to its configuration before the failure of the central pier foundation. The actions included the underpinning of the central pier, the complete dismantling of the central vaults, the restitution of the upper geometry of the pier, and finally, the reconstruction of the vaults using mass concrete as filler. Most of the existing stones have been repaired and reused, while a similar limestone has been used for the new pieces. Finally, the foundation of abutment 1 has also been reinforced and pier 3 foundation undermining finished.
