Balaidos Stadium roof structure reinforcement study

Vigo, Spain / 2017-

reinforced concrete structure for changing the existent roof by a lighten one
feasibility study for different solutions which could resist Balaidos Stadium roof change
COPASA
COPASA
detailed design and construction support

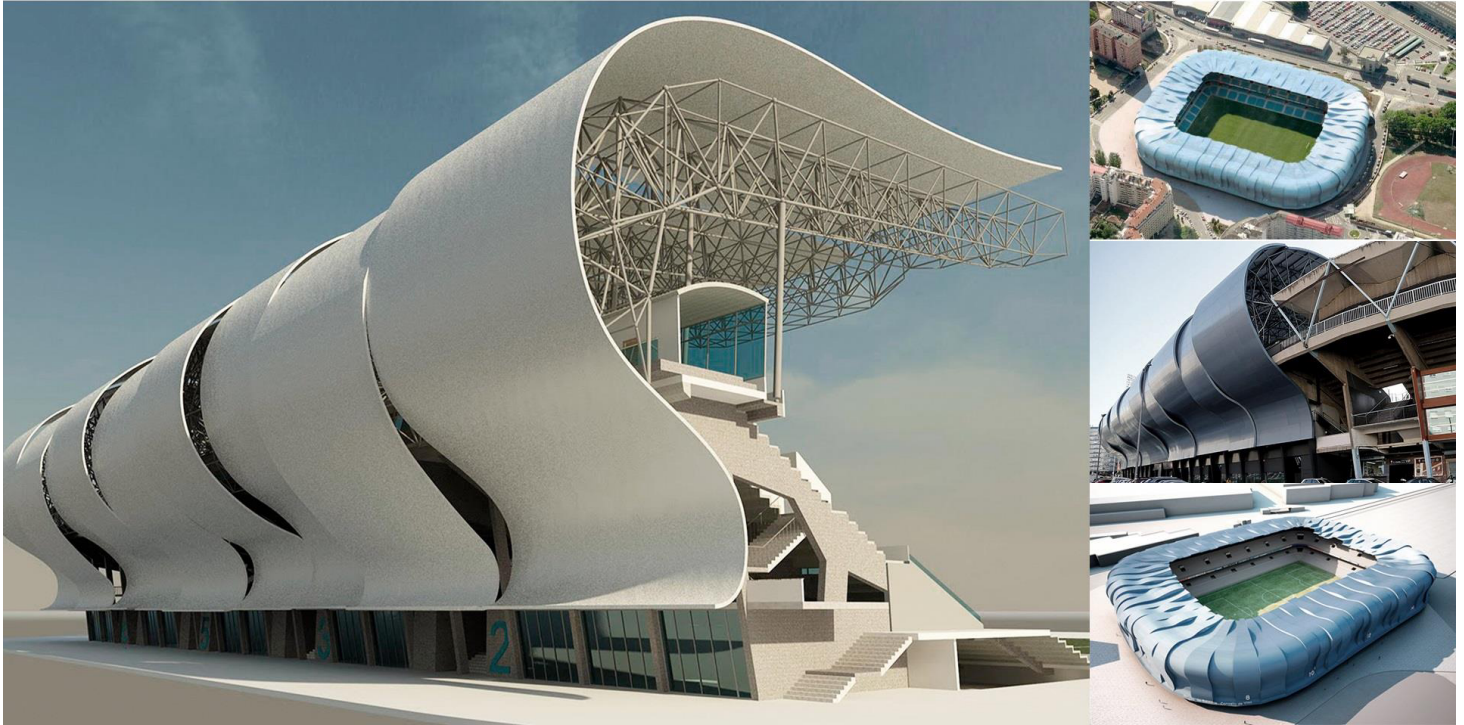
Balaidos stadium (Vigo, Spain) was built in 1960. In this year, three grandstands were executed (grandstand "Goal", grandstand "Scoreboard" and grandstand "North"). Subsequently, and on the occasion of celebration of the World Cup, the grandstand "River" was built in 1981 to complete the stadium. The structure built at the beginning of the 60s consisted of reinforced concrete frames every 5.65m and the roof consisted of reinforced concrete shells. The cantilever span of the roof is 17.00m and the distant between support point on the frames is 4.50m. The grandstand "River" built later consists of reinforced concrete frames (columns and beams) every 8.40m of greater importance. Roof consists of a light 3D steel structure formed by spherical joints and tubes. Roof cantilever span is 22.40m and the distance between supports on the frames is 11.20m.

A remodeling of the stadium has been proposed in different phases. The first phase of the remodeling focused on the grandstand "North". The remodeling consisted in the extension of the grandstands towards the playing field and the replacement of the concrete cover roof a new high steel roof up to 25.80m cantilever in order to cover the entire extension of the new stands. The new roof supports a new architectural skin that also extends in continuity with the façade, which changes from being a wind-permeable roof to a closed structure. This radical modification of the roof totally modifies the reactions on the concrete frames since the wind exposure is much more conditioning.

Fhecor Ingenieros Consultores was hired by COPASA, to evaluate the need to reinforce the concrete frames and foundations. After the evaluation of the existing structure, a reinforcement of the frames is proposed, consisting of an external post-tensioning of the upper lintel and the columns. This is an innovative solution that allows to increase the bending capacity of the frames. To materialize this solution, strands are arranged on each side of the frame.
