Restoration of nº6 in C/Salustiano de Olózaga

Salustiano de Olózaga Street nº6. Madrid / 2009

Structural type
Owner
Client
Scope
Architect

brick load-bearing walls and wooden struts and joists
Inversiones Casado del Alisal, S.A
Joaquin Gil de Bernabé Arquitecto
detailed design and construction support
Luis Joaquin Gil de Bernabé

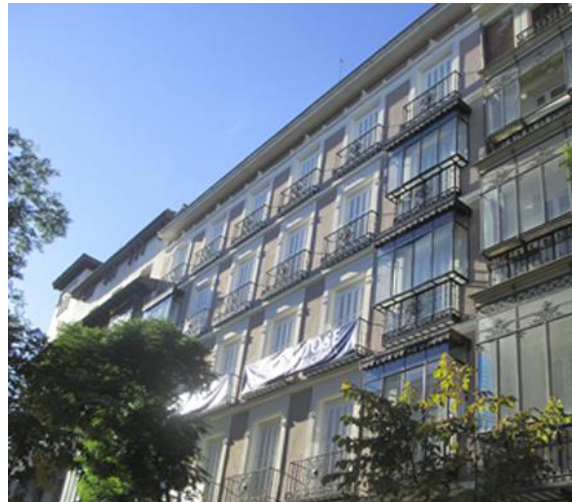
The building is located at N°6 in the Calle Salustiano de Olózaga in Madrid and dates back to the 19th Century and is a perfect example of the noble construction of this period: Load-bearing walls composed of a framework of studs and sleepers, braced with masonry brickwork and lime mortar. These walls were normally arranged parallel to the main façade, acted as supports to the wooden joist flooring which made up the five floors of the building.

This is a global structural rehabilitation Project which in its first phase will stabilize and reinforce the structure on grade with a steel framework and in a second phase will excavate the building below grade so as to obtain three levels of car parking. The process will consist of micro-piling a slab on the first floor which will receive the loads from the building above grade and then consequently excavate the building below grade level.
